ECBC-TR-526

EVALUATION OF THE STERIS SENSITIVE EQUIPMENT DECONTAMINATION (SED) APPARATUS ON A 463L PALLET

September 2007

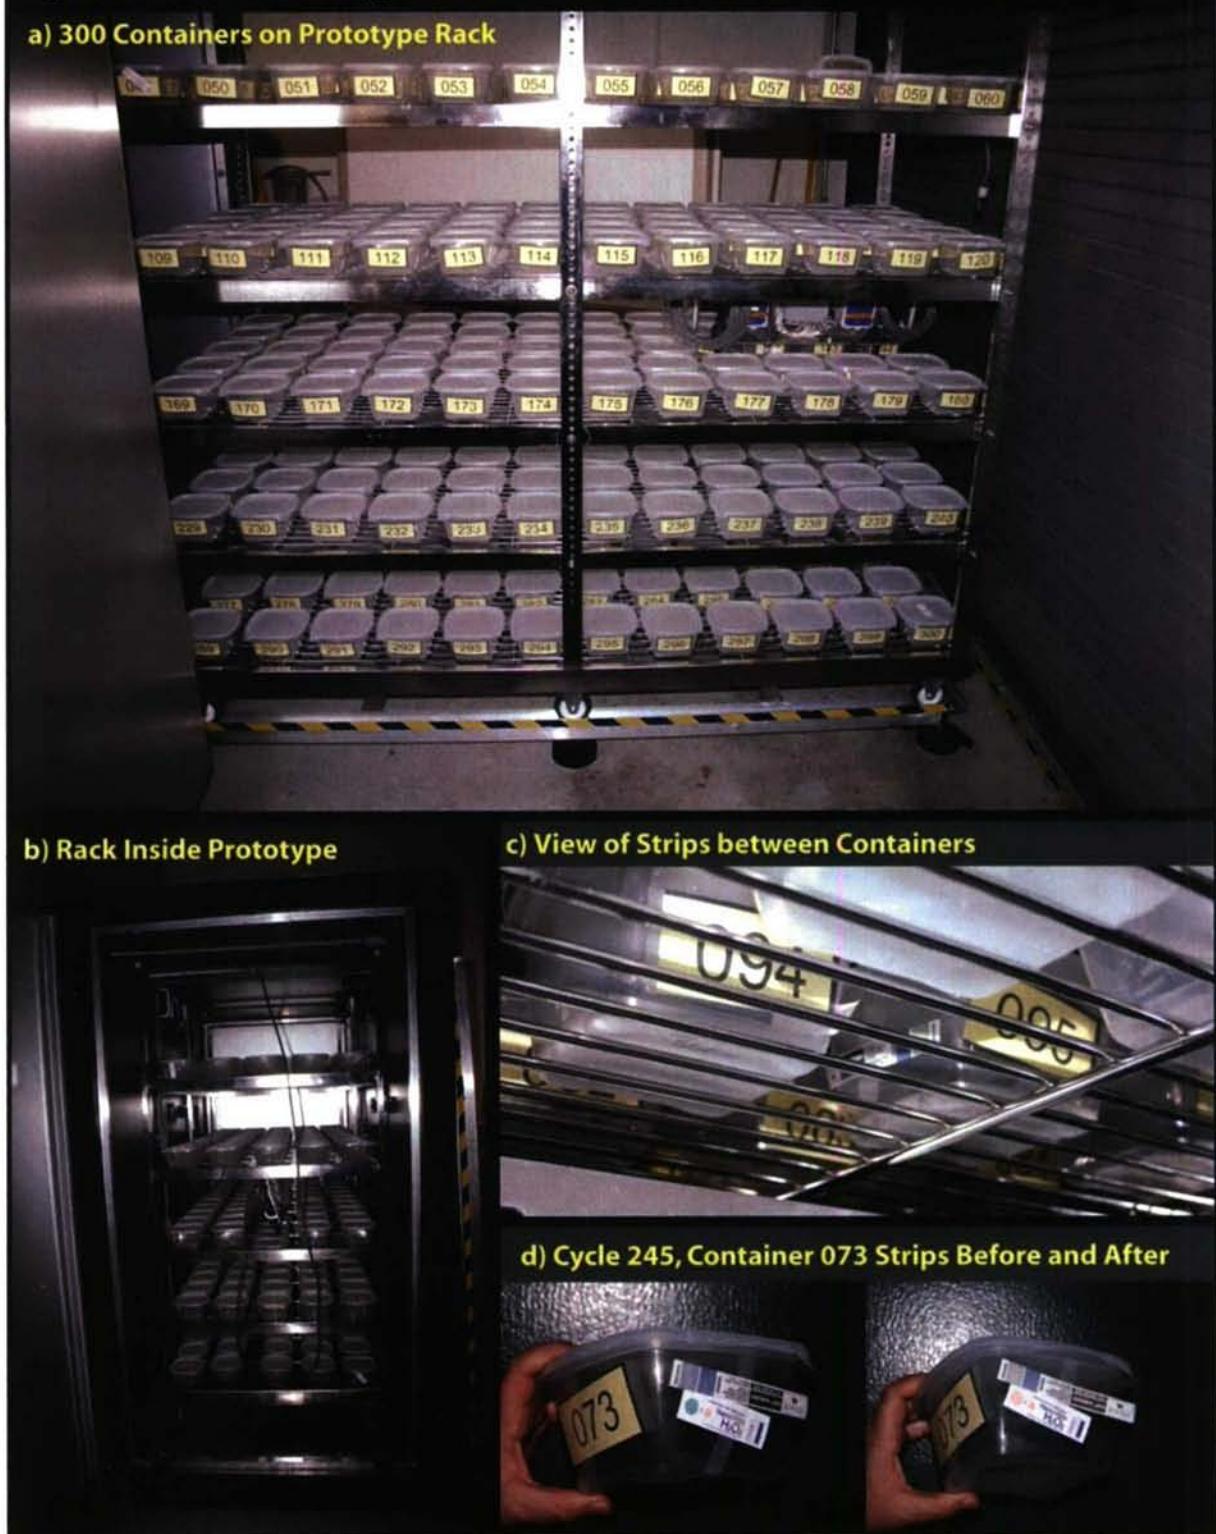
Figure 3.5.3: SED Prototype Loaded with 300 Containers

The 300 containers were numbered and loaded into the SED prototype (Figure 3.8.3.1a). The chemical indicator strips were applied to the appropriate container and side using a single-sided adhesive tape (3.5.3c). The rack was pushed into the decontamination chamber (Figure 3.5.3b). The cycle was performed. After aeration was complete, the chamber was unloaded and the chemical indicator strips were removed and archived. A sample of cube 073 before and after the cycle is shown in Figure 3.5.3d. The strips were visually reviewed and archived. All strips showed a similar color response regardless of position within the decontamination chamber. All strips showed contacting with hydrogen peroxide.

The loading test was performed using the equipment rack as-received. The rack consisted of 5-stainless steel shelves spaced at approximately 12-inches apart. Figure 3.5.3b shows that the loading of the 300 containers onto the five shelves does not completely fill the decontamination chamber. If additional shelves were available, it is anticipated that the number of containers could be increased while maintaining fumigant distribution.

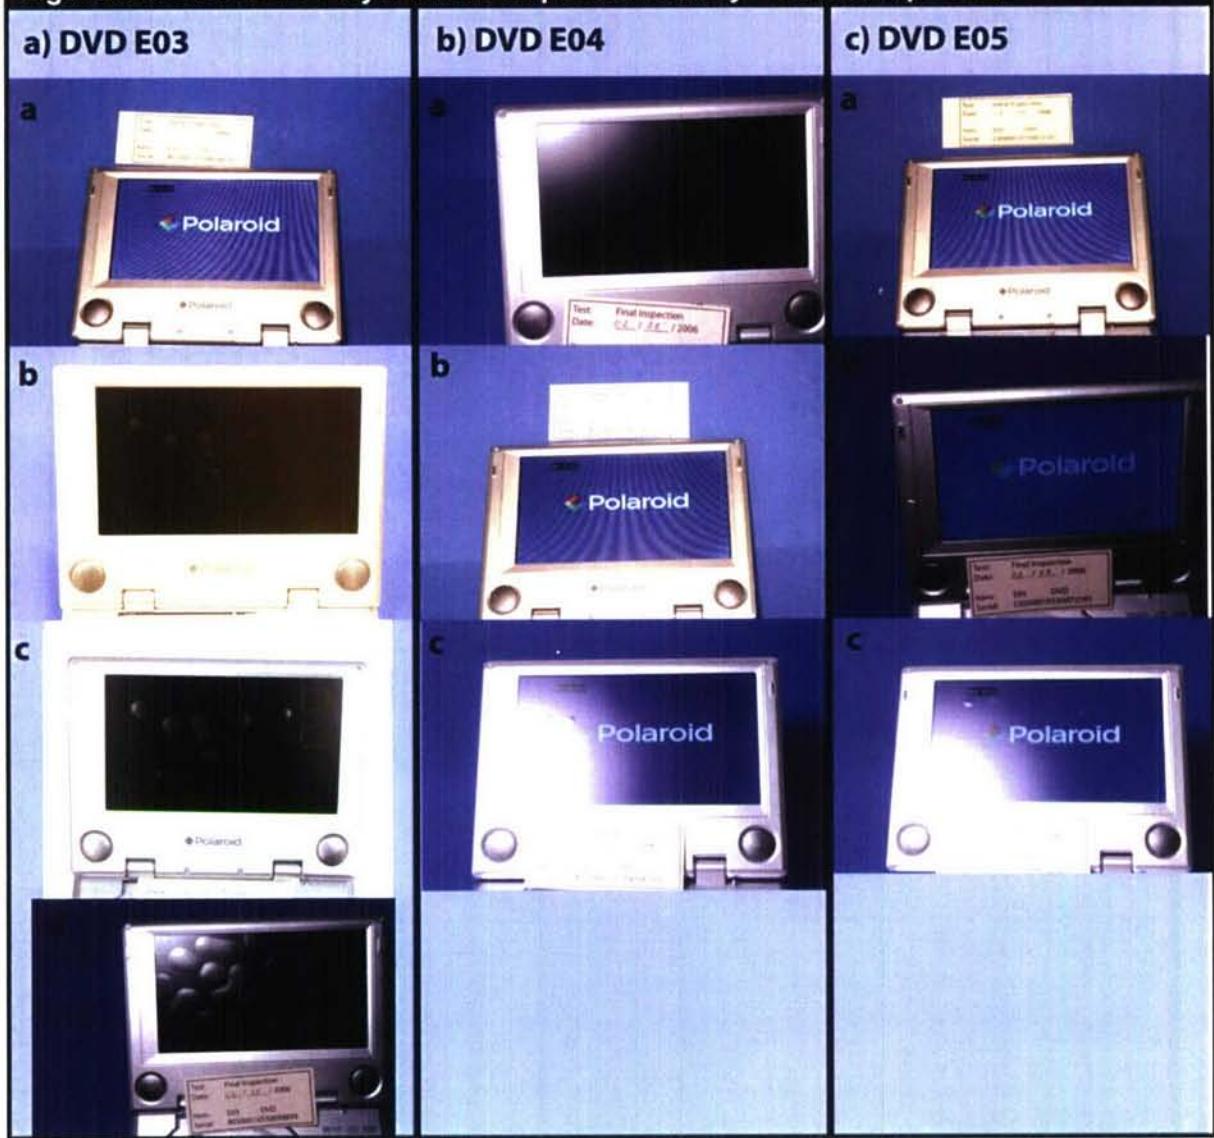
Figure 3.6.4.2.2: DVD Player mVHP Exposure History - Visual Inspection

DVD E01: DVD E01 was inserted into the SED box for testing starting with Cycle 304, Equipment Test 1.1, on 8 February 2006. After 23 hours of exposure, no changes were observed. (Figure 3.6.4.2.2) DVD E01 underwent a total CT of 12716 ppm-hr peroxide and 812 ppm-hr ammonia.

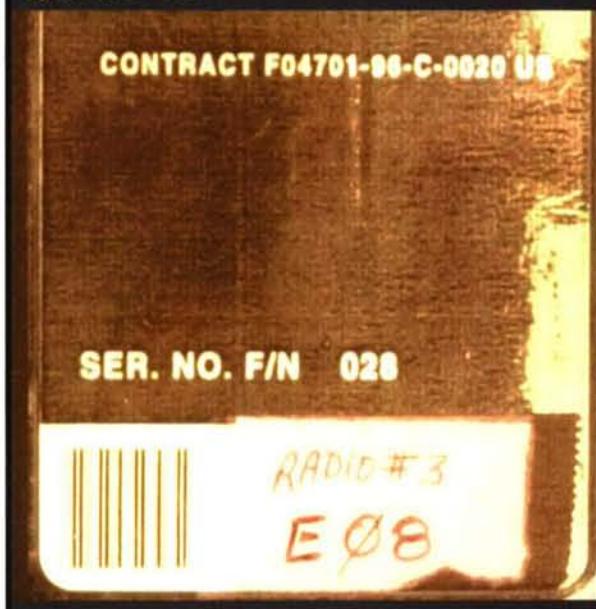
Figure 3.6.4.3.2: Radio mVHP Exposure History - Visual Inspection

Radio E08: Beginning with cycle 304, Equipment Test 1.1, on 8 February 2006, Radio E07 was inserted into the SED box. After 23 hours of exposure, no effects were observed. After 32 hours of exposure bubbling was observed on the back label. Radio E08 underwent 111 hours of exposure and a total CT of 60628 ppm-hr peroxide and 3663 ppm-hr ammonia. Figure 3.6.4.3.2-E08a was initial photo, 3.6.4.3.2-E08b was final inspection.

Example on bubble highlighted

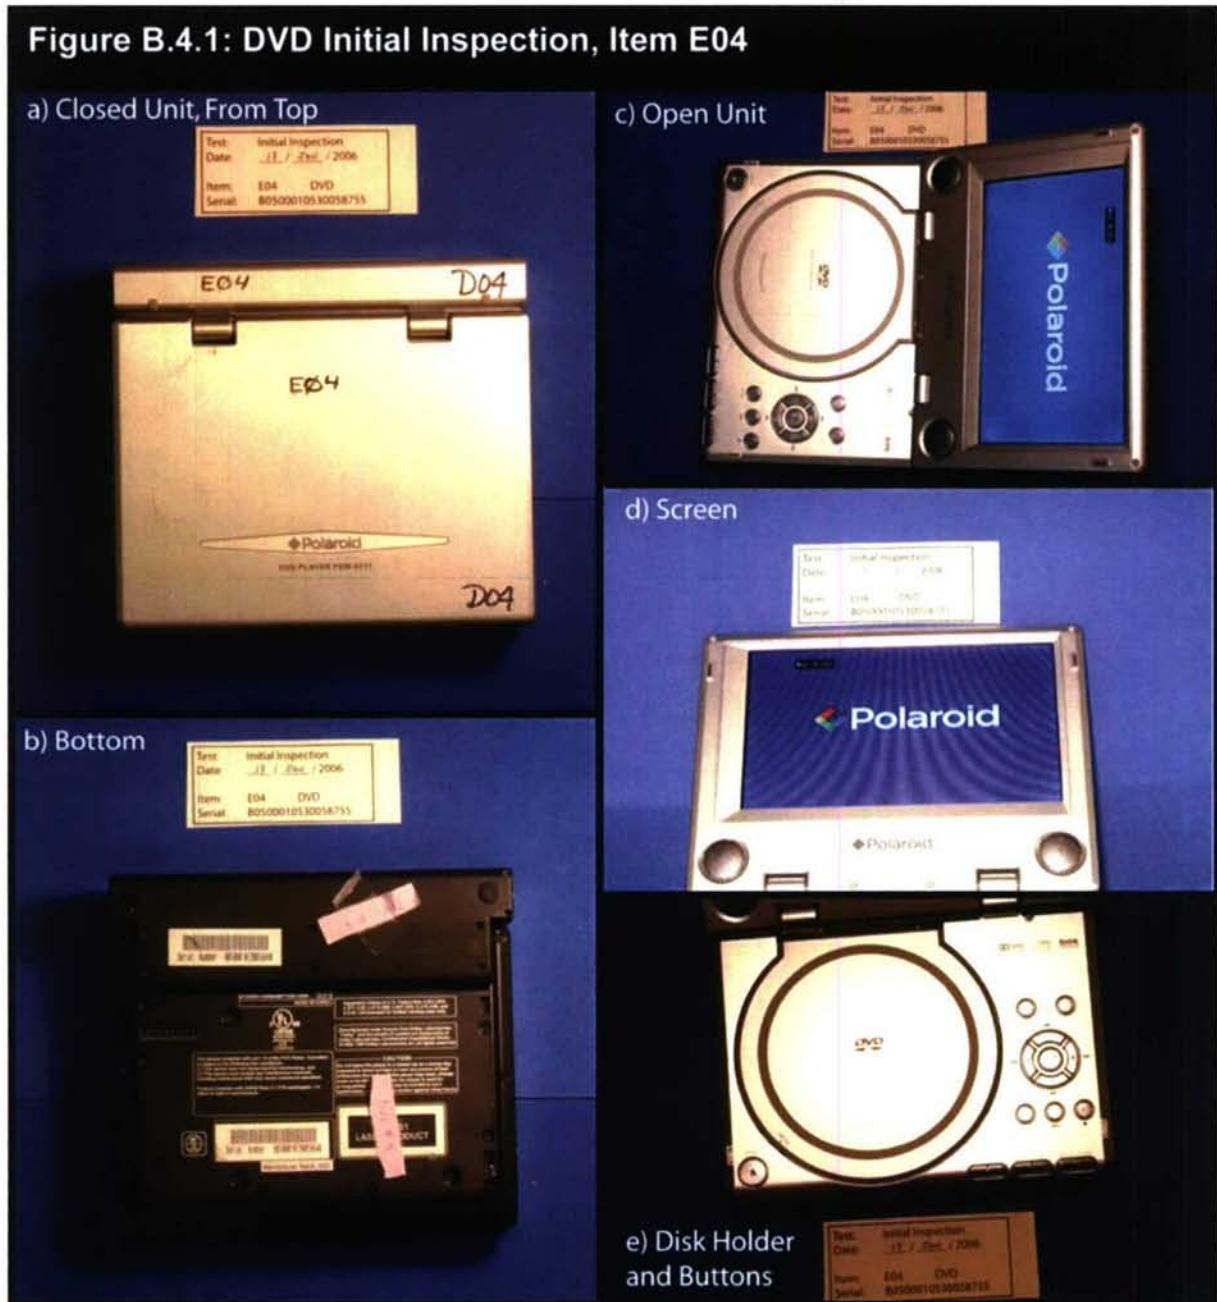
Figure B.4.1 Initial Inspection DVD Player E04

DVD E04: DVD E04 was inserted into the SED box for testing starting with Cycle 304, Equipment Test 1.1, on 8 February 2006. After 110 hours of exposure, no immediate effects were observed. The test director suggested that the items should be stored and monitored for a few months after the end of the exposure testing. During a follow-up inspection one week later, the test team observed two small bubbles that had appeared on the screen. Once started, these bubbles grew slightly larger, as observed in subsequent follow-on inspections. DVD E04 underwent a total CT of 59905 ppm-hr peroxide and 3615 ppm-hr ammonia. Figure 3.6.4.2.1 E04a was taken during the initial inspection, 3.6.4.2.1 E04b was taken during the final inspection, and 3.6.4.2.1 E04c was taken during the first post-trial storage inspection.

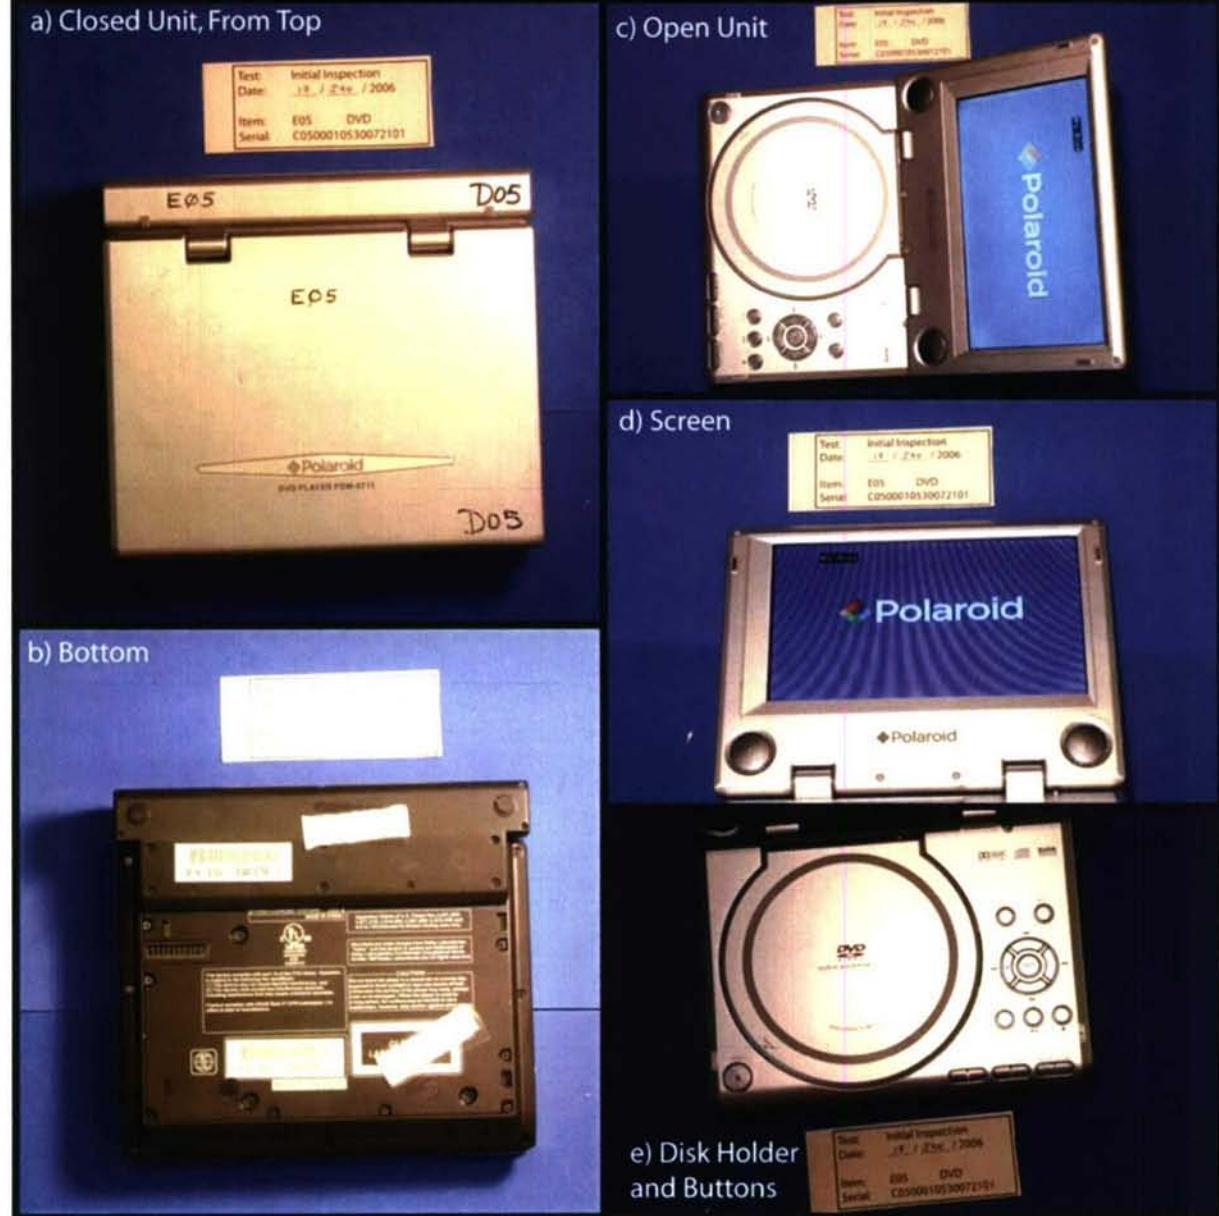
Figure B.5.1 Initial Inspection DVD Player E05

DVD E05: DVD E05 was inserted into the SED box for testing starting with Cycle 304, Equipment Test 1.1, on 8 February 2006. After 110 hours of exposure, no immediate effects were observed. Re-examination one week later unveiled two small bubbles appearing on the screen. DVD E05 underwent a total CT of 59905 ppm-hr peroxide and 3615 ppm-hr ammonia. Figure 3.6.4.2.1 E05a was taken during the initial inspection, Figure 3.6.4.2.1 E05b was taken during the final equipment inspection, and Figure 3.6.4.2.1 E05c was taken at the first post-trial storage inspection.

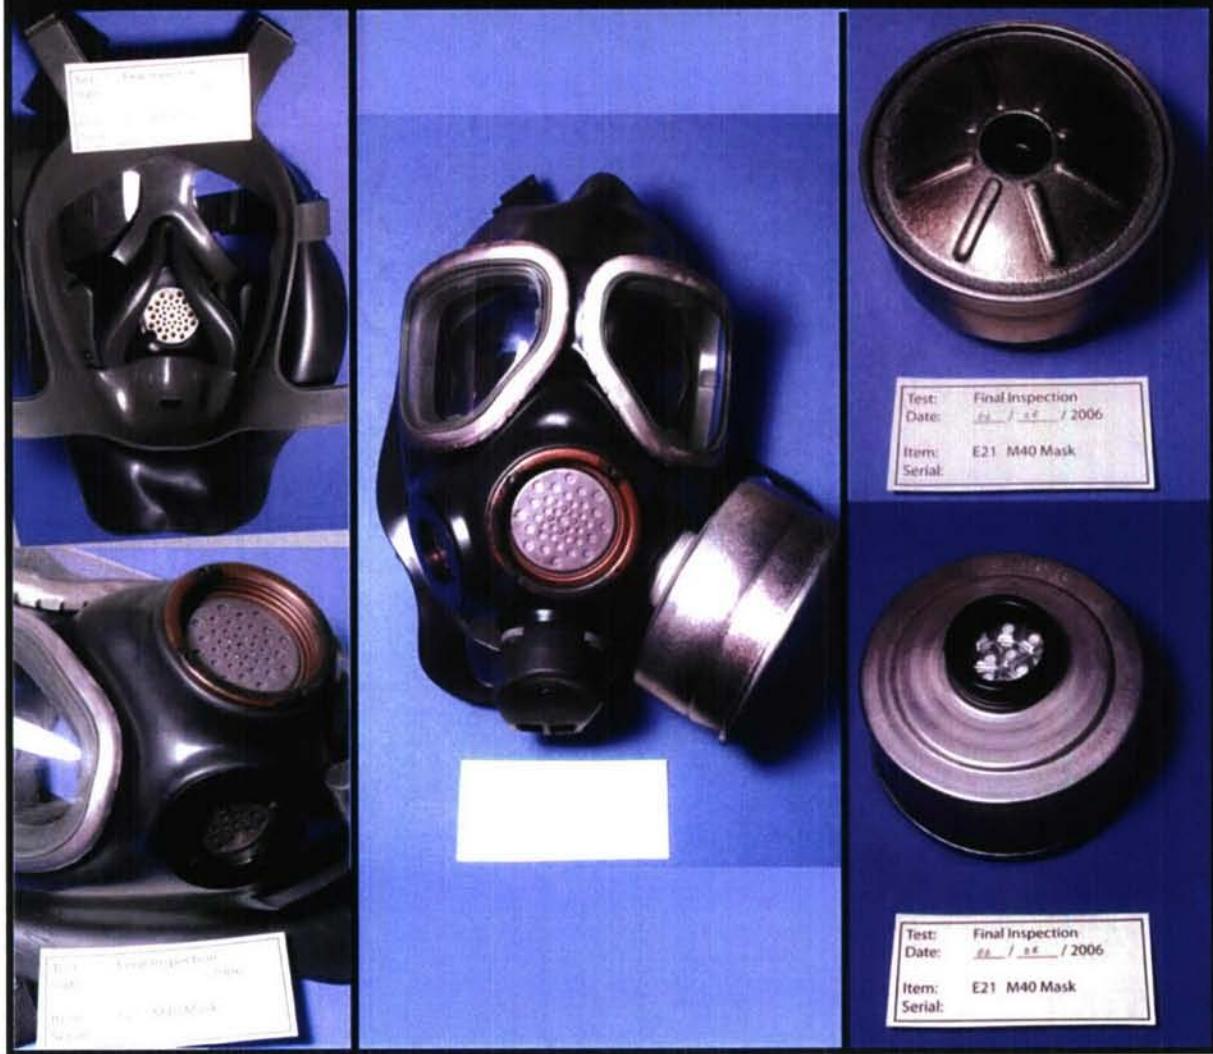
Figure B.21.2 Final Inspection Mask E21
